PHASE I ENVIRONMENTAL ASSESSMENT

Desimone/Global Intermodal Systems
1818 South 93rd Street
Tukwila, King County, Washington 98108

December 15, 2004

Property Solutions Project No. 20042382

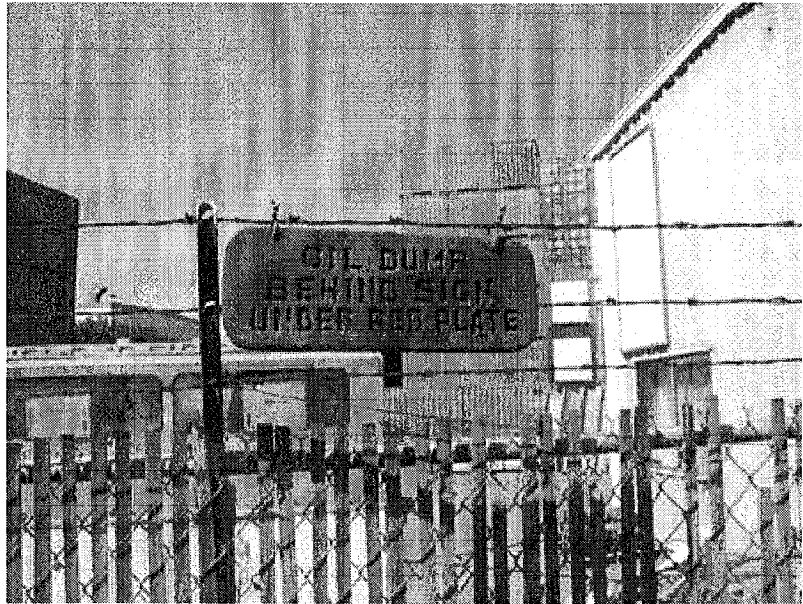
Property Solutions observed a sign hanging on a fence separating the Duwamish Yacht Club property from the GIS property that stated "Oil Drop Behind Sign - Under Red Plate." Property Solutions did not observe a red plate on the GIS property, however, Property Solutions did observe a metal plate located immediately south of the small repair shop located along the east side of the GIS property. In addition, an asphalt patch measuring approximately 10' x 6' was observed adjacent to the metal plate. This suspect area may have previously contained an underground storage tank. The subject property was not listed in Ecology's databases as a Registered Storage Tank site. Property Solutions is currently awaiting a response from the King County Fire Marshal's office regarding records indicating the former/current presence of an underground storage tank (UST) at the subject property. The Seattle and Tukwila Fire Departments do not have jurisdiction on the subject property.

PHOTO 15. Suspect UST indicator

If no information is maintained for this suspect area by the King County Fire Marshal's office, a geophysical survey to determine the absence/presence of an UST would be warranted. In addition, a subsurface investigation would be required to determine if the historical presence of a UST has adversely impacted the environmental condition of the subject property.

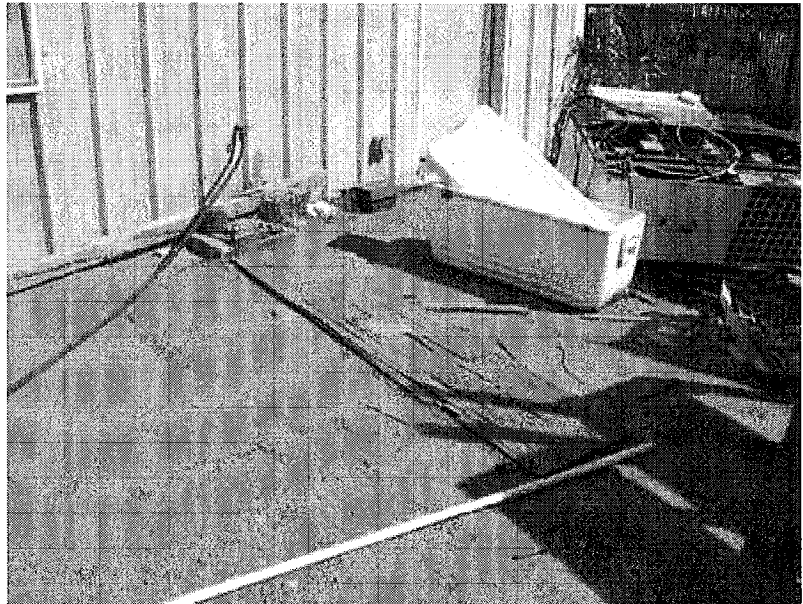
PHOTO 16. Suspect location of former UST

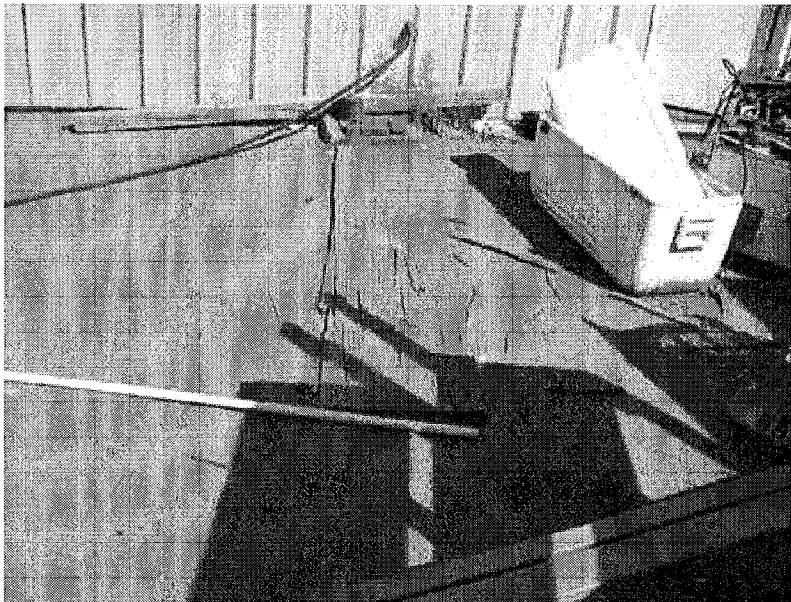
PHOTO 17. Suspect former UST location

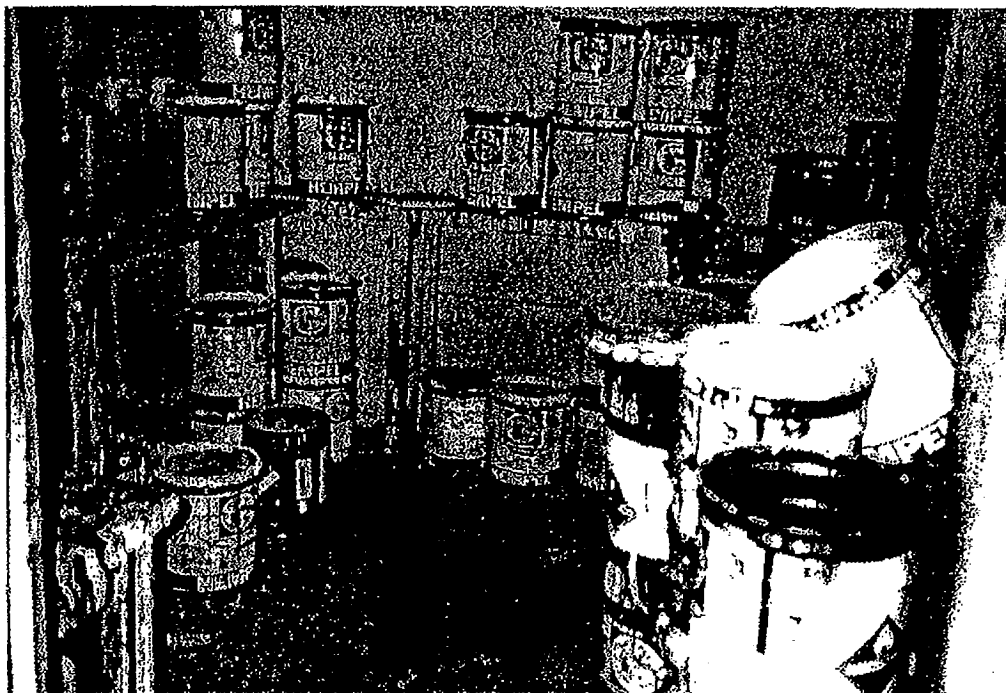
2. View of paint storage room. Note paint staining. Xylene drum on right wall behind paint (black object is pump in drum).

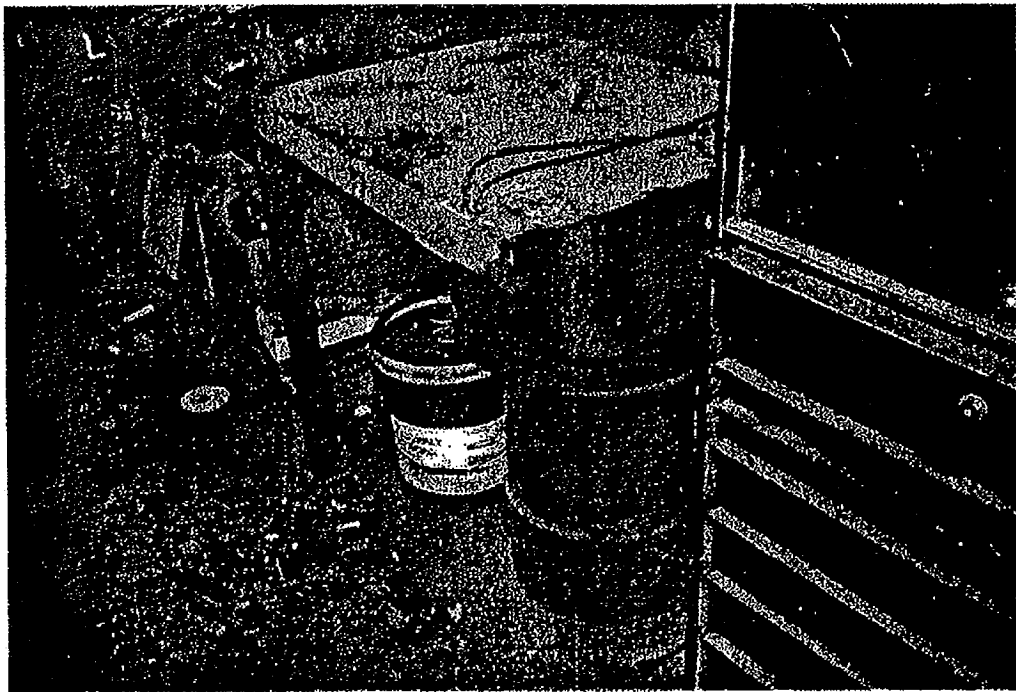
3. View of parts washer on north wall of main shop. Note minor black staining on concrete floor.

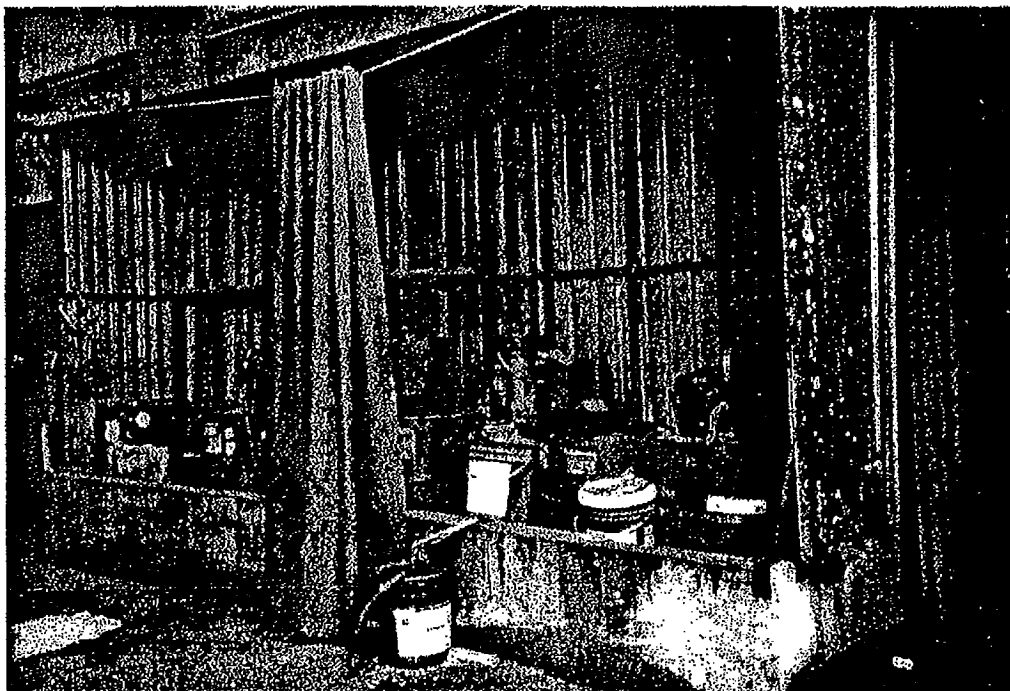
5. View of new and used oil storage area in main shop building. Note absorbent material at lower left.

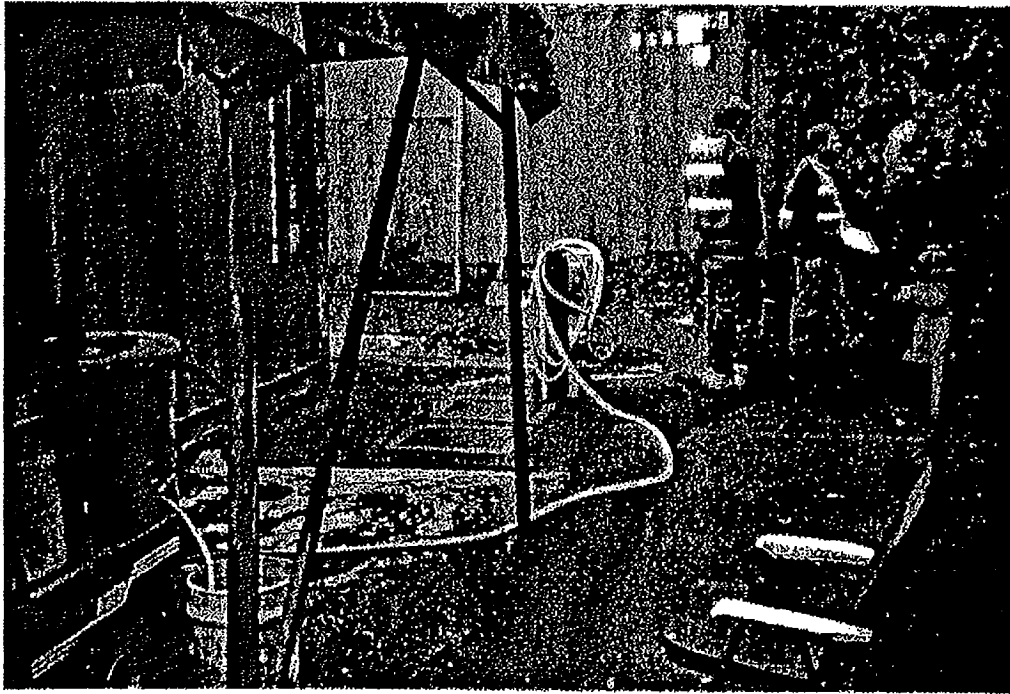
7. View of western wash area trench drain and settling tanks. Trench drain in background and settling tanks are beneath the two metal plates in the center of the photograph. Note asphalt berm surrounding area. Water treatment container in background.

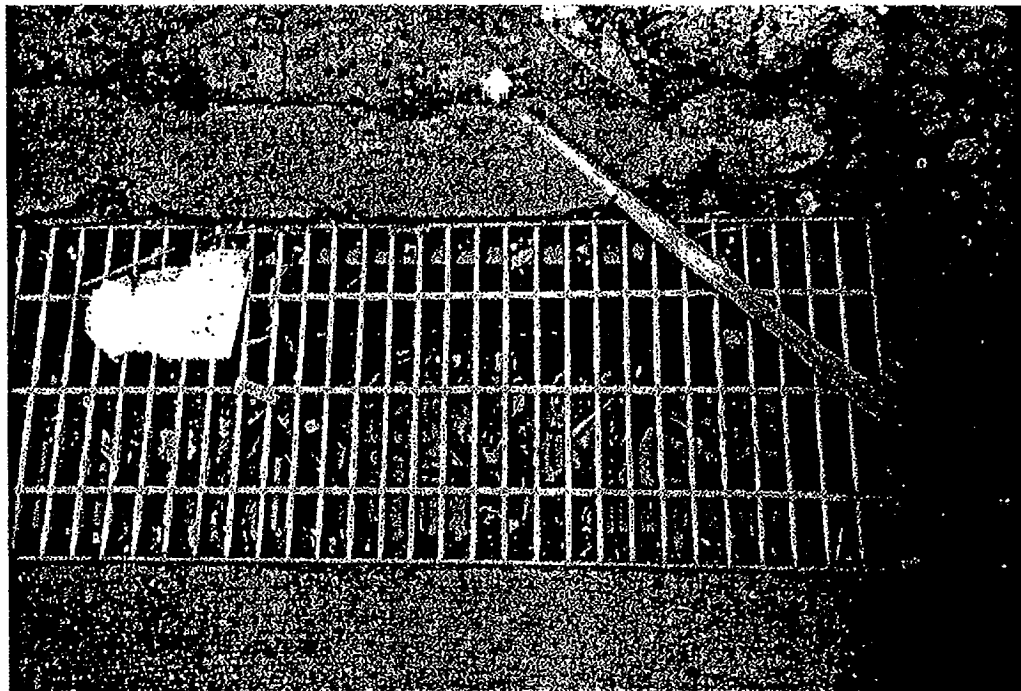
10. Close-up view of trench drain for the eastern wash area. Note debris in water.

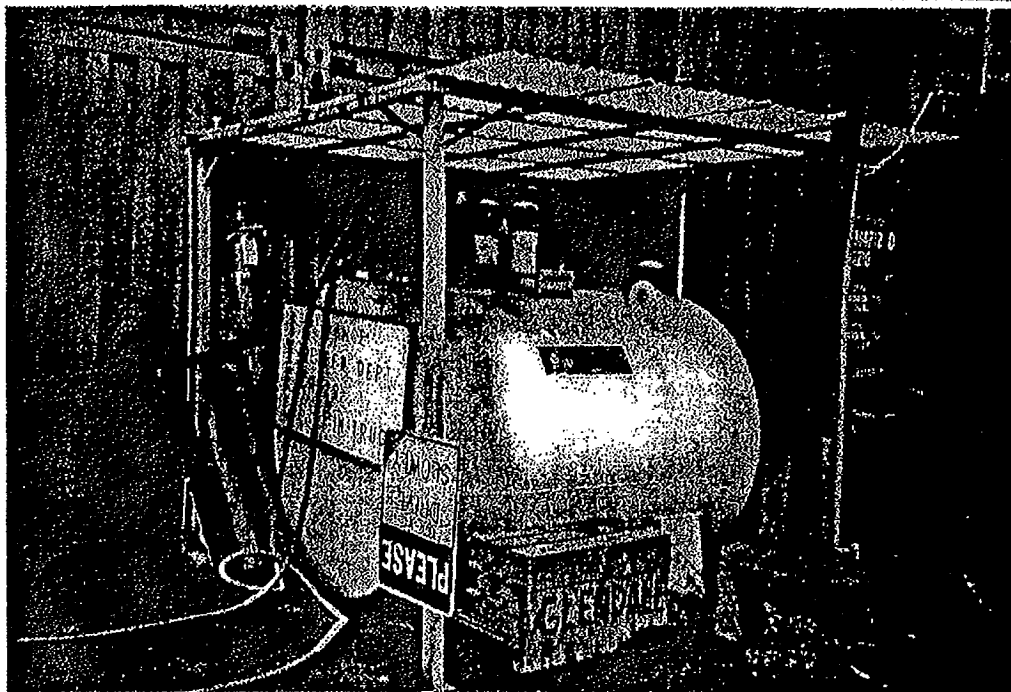
11. View of diesel AST in fueling area. Note minor staining on asphalt near hose.

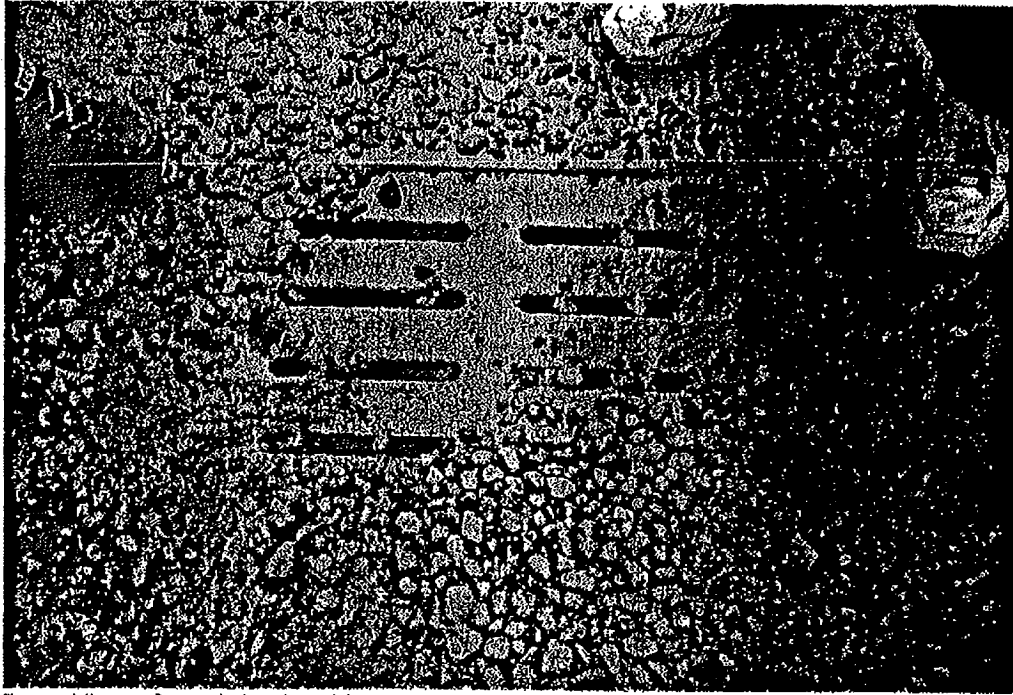
15. View of catch basin with no filter sock. Note sediment and rocks entering basin. This catch basin located in the unpaved area of the site in the container storage area near the entrance gate.
